KOOTENTAI DEVELOPMENT IMPOUNDMENT DAM
TOE DRAIN INSPECTION II REPORT

July 27, 2010

BHI File No.: R.56.6

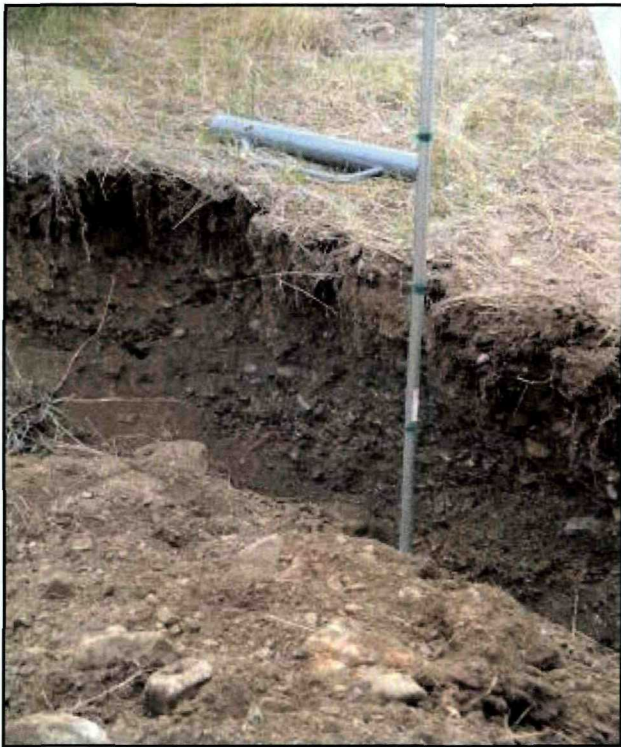
FIGURE 19: MATERIAL NEAR PIEZOMETER A10.

It is interesting to note that the excavated material near A11 was a very coarse material with large 1 ft. to 2 ft. diameter boulders in a coarse gravel and sand matrix. There were lenses of coarse sand in the matrix that appeared to be water layers at approximately 4 ft. below the ground in the hole south of A8. A photograph of the excavation is shown in Figure 19 below.

The two other holes were mainly fine grained silt, sand and rocks to 6 feet below ground surface. Why there is a difference in the geology is not clear other than to assume the area near drain 1 and drain 2 was embankment or other fill material and the area south of A8 was assumed to be native material.

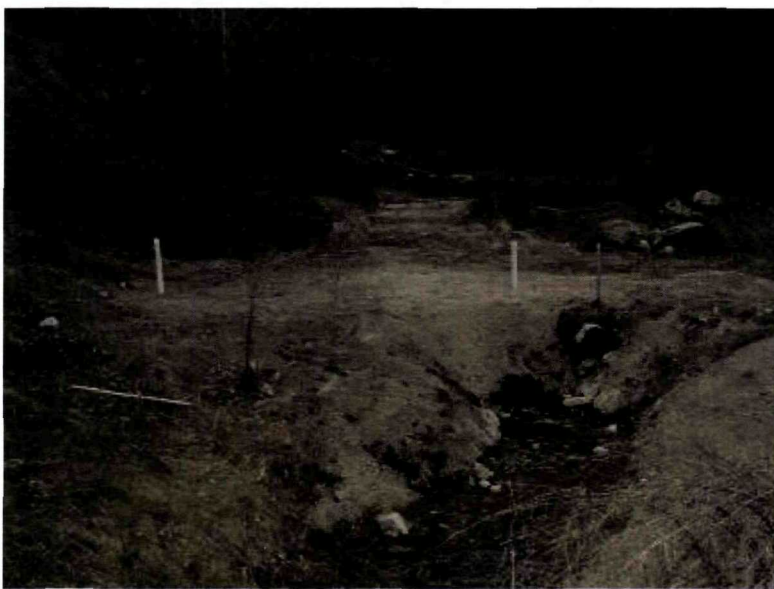
FIGURE 20: PIEZOMETERS A9 AND A10 NEAR DRAIN 2 AND DRAIN 1

A photograph of the piezometers A9 and A10 after they were final graded is shown in Figure 20 below.

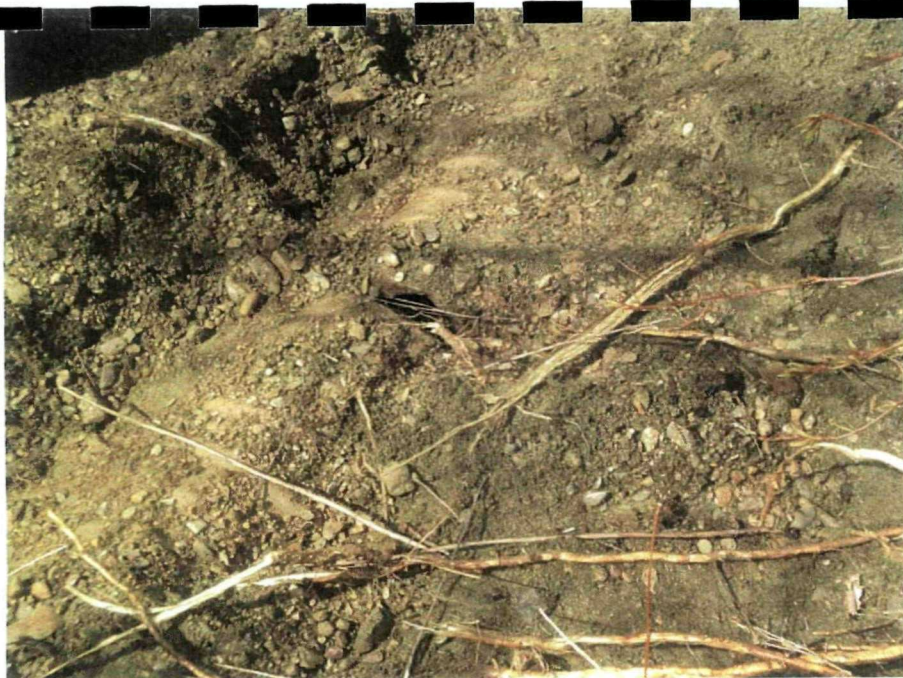
4. Gravel size on invert of drain 7

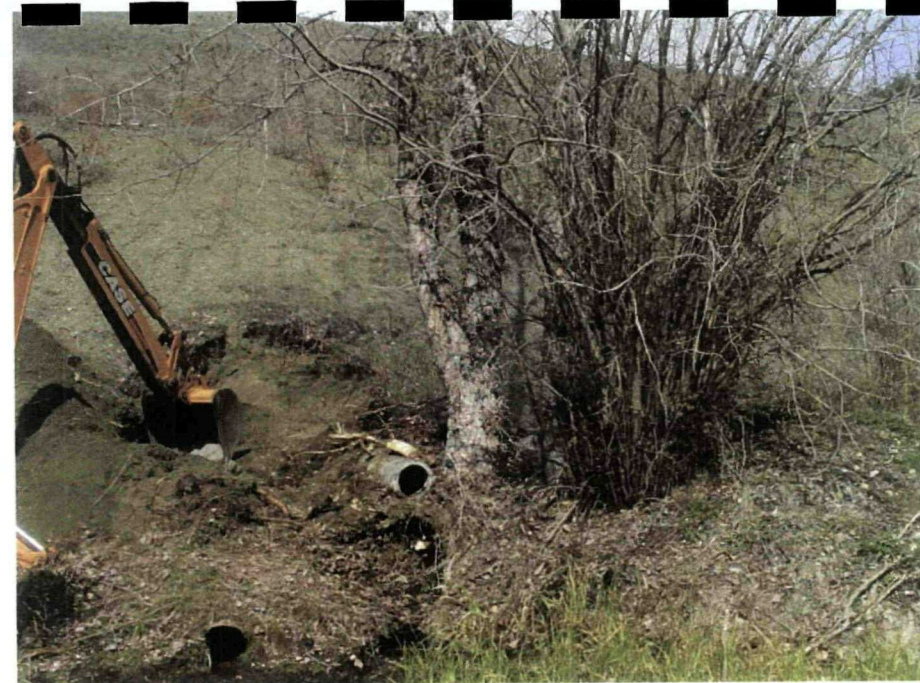
5. Drain 7 on top just before excavation

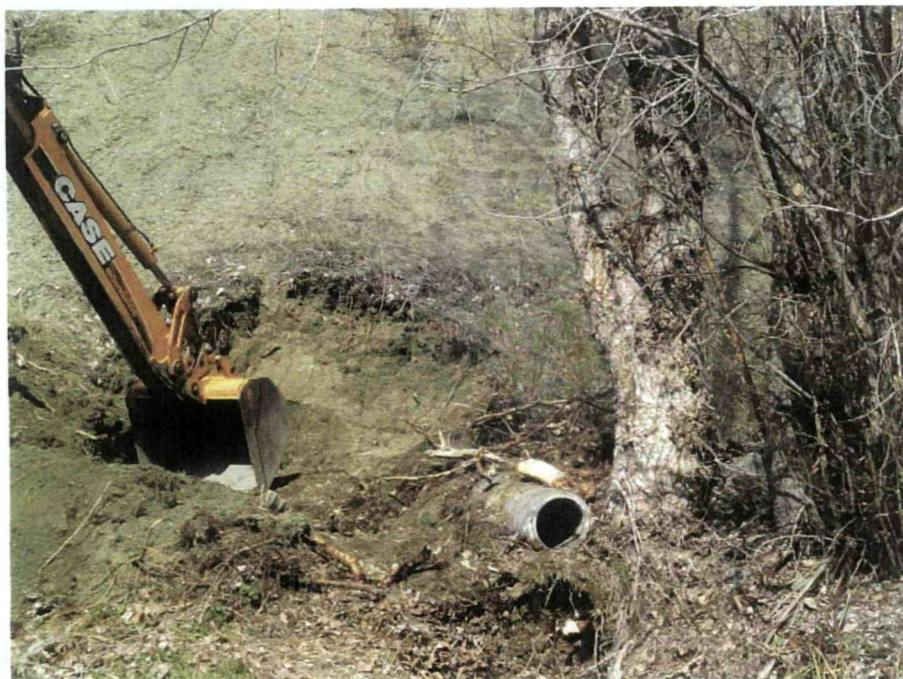
6. Drain 7 at outlet

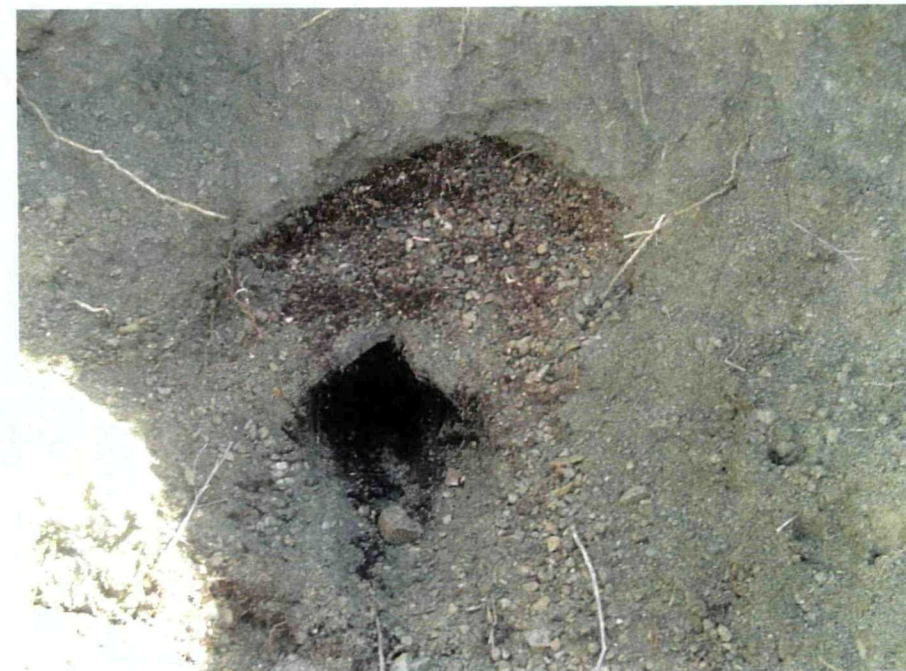
7. Drain 7 at outlet before removing cottonwood

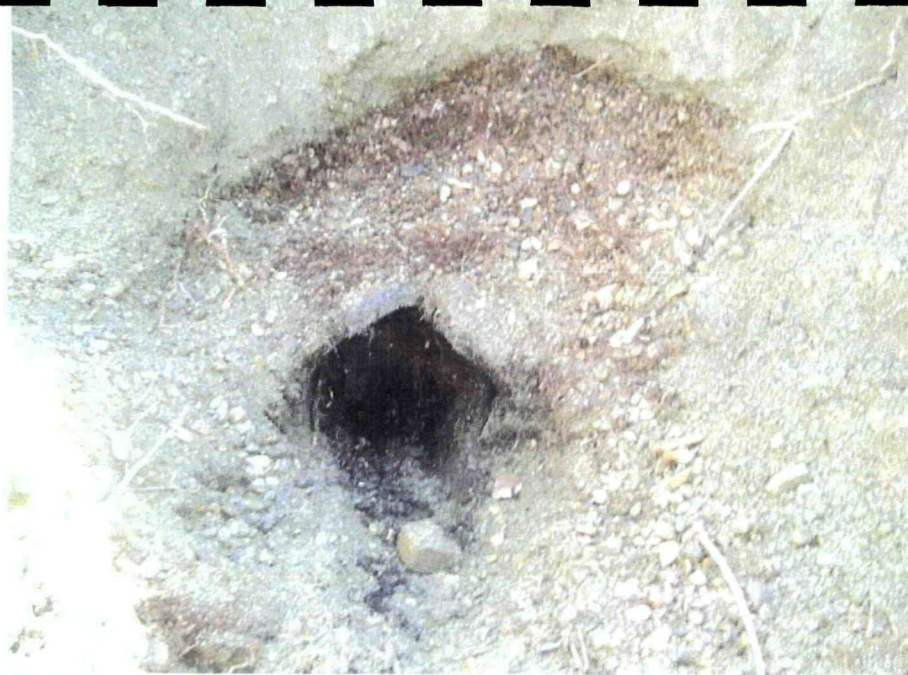
8. $\frac{3}{4}$ " minus round gravel around drain 7

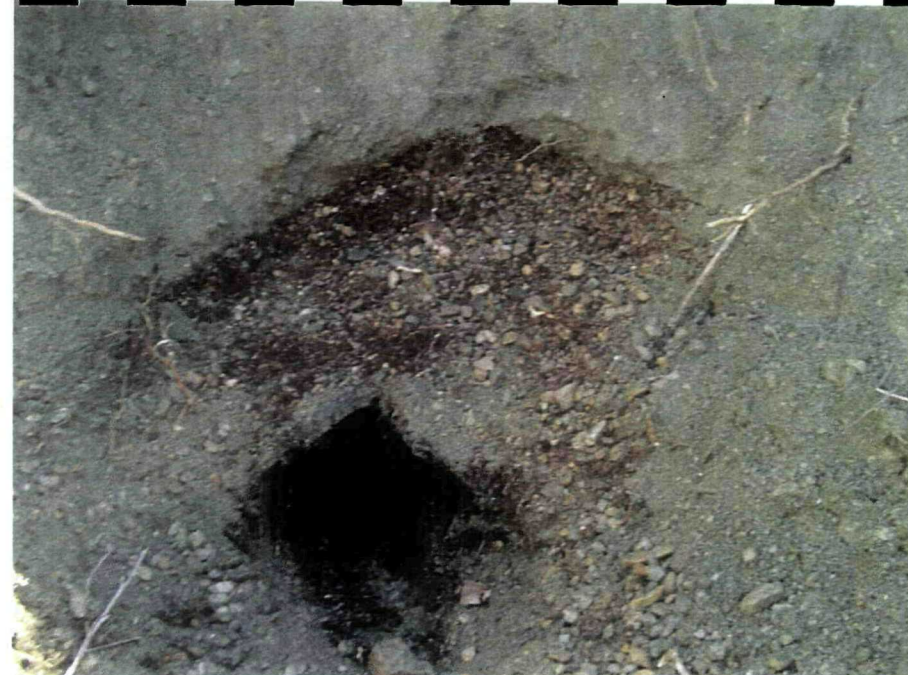
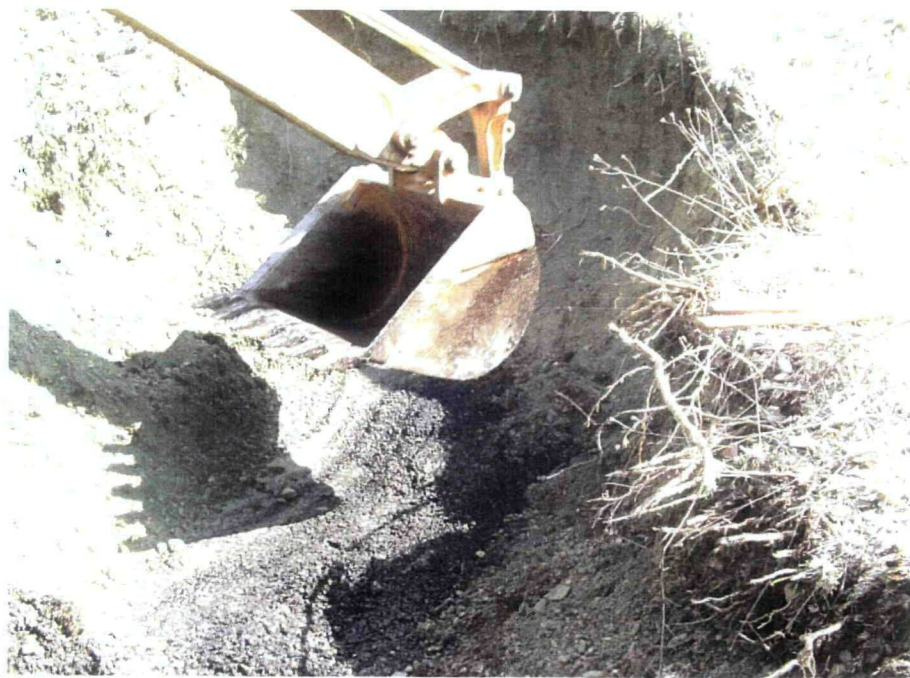
9. Gravel around drain 7

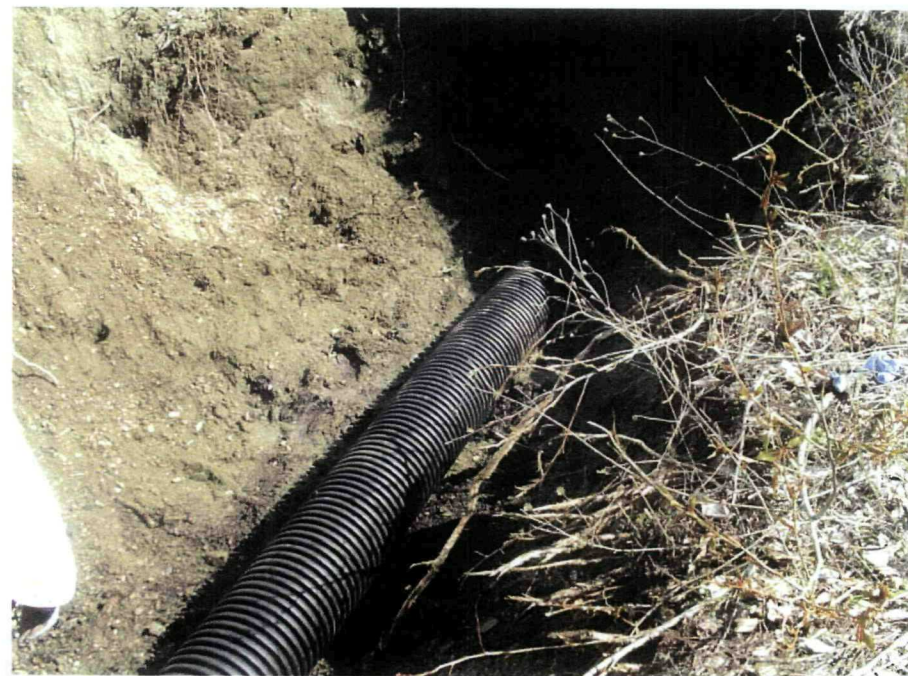
11. Gravel under drain 7

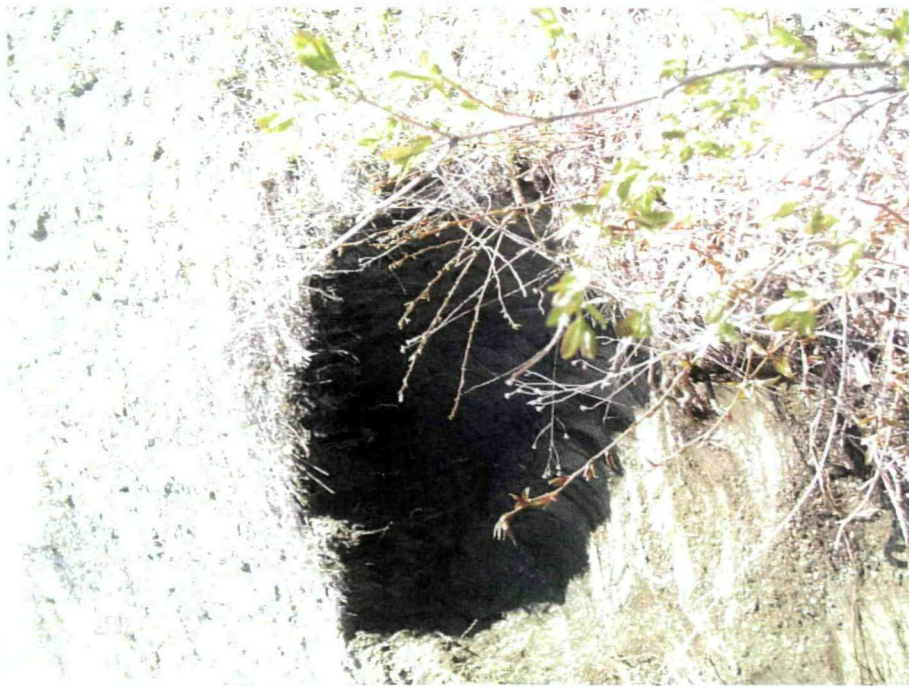
12. New outlet for drain 7

A new 20 ft. 8-inch HDPE pipe was placed at the end of the existing pipe and bedded in the gravel matrix. Water was found to be flowing in the gravel matrix below the old pipe invert and emerging from the gravel below the outlet end of the pipe so the invert of the new pipe was lowered, the slope was steepened and slots were cut into the pipe in hopes of capturing some of the flow in the gravel. A photograph of the new outlet is shown in Figure 3.

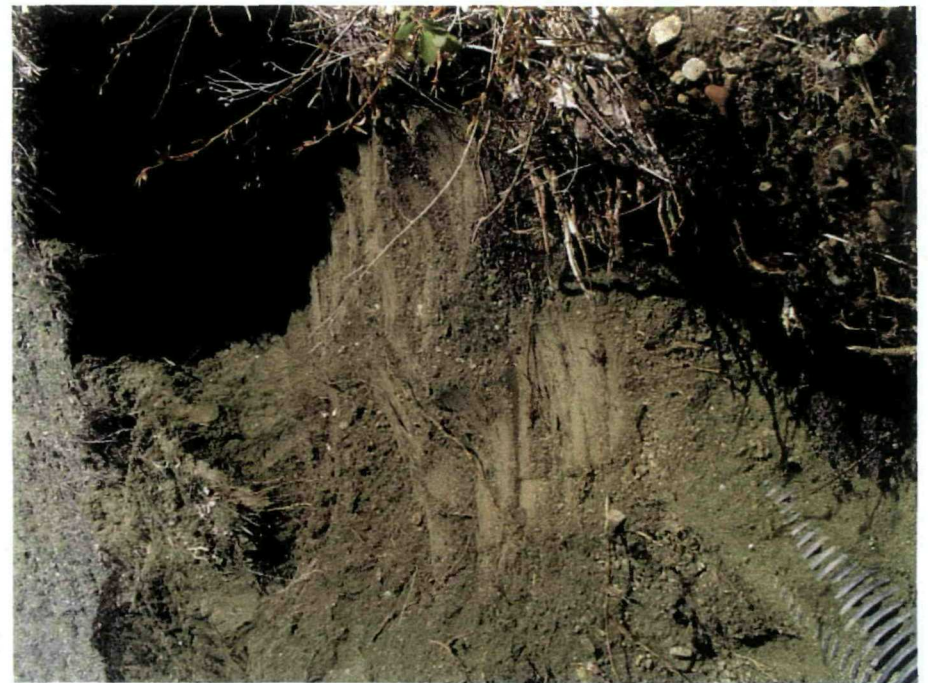
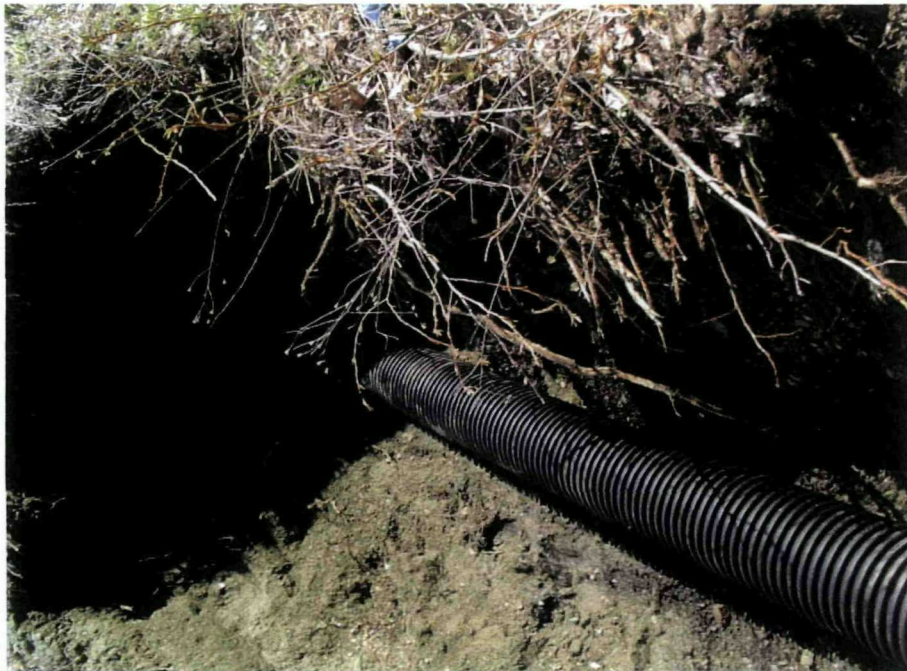
13. New fill over drain 7

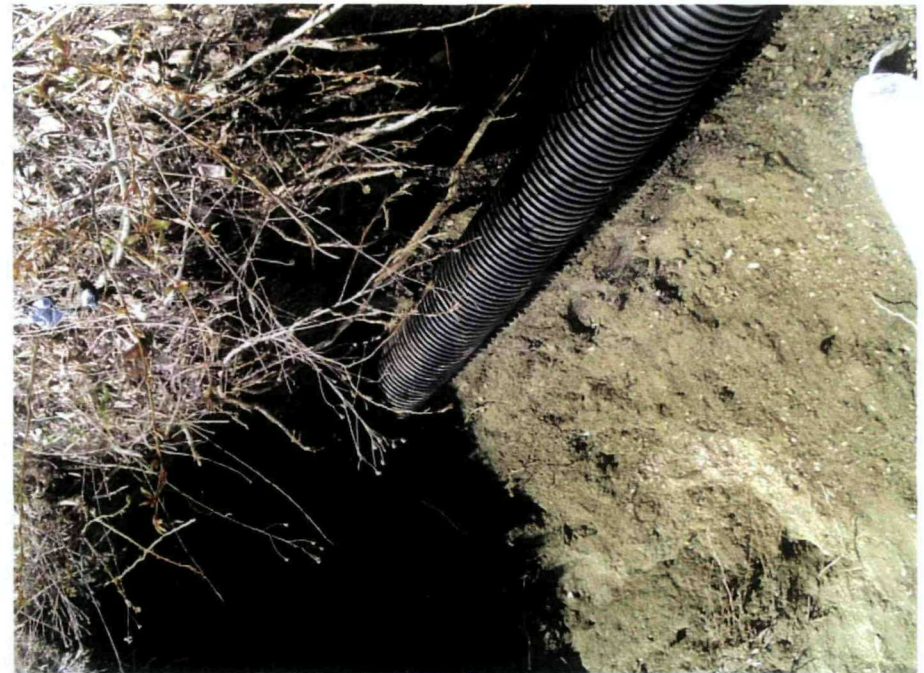
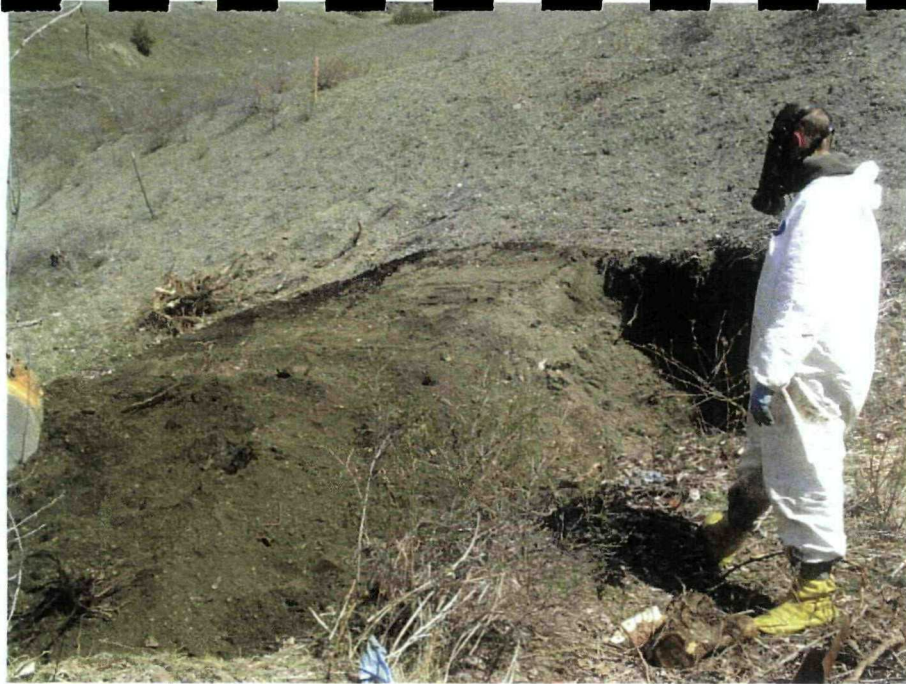
15. New outlet drain 7

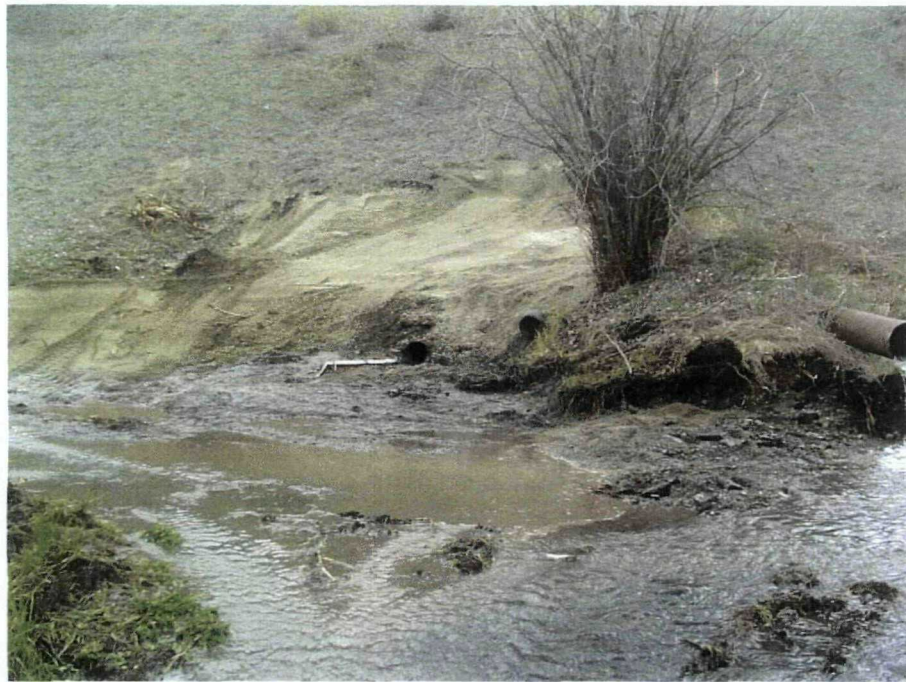
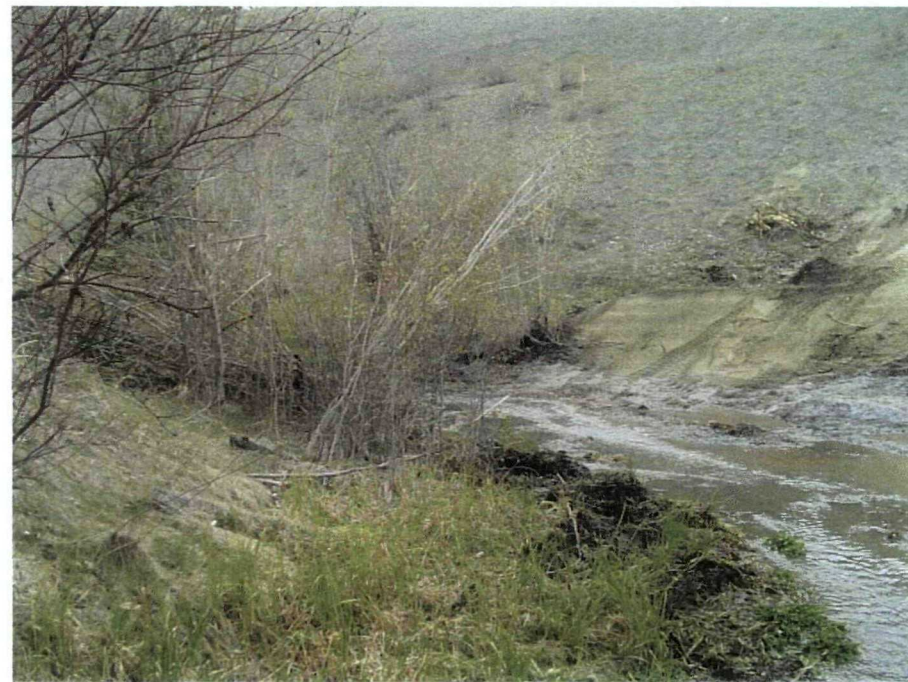
18. Final grading, drain 8, drain 7, & drain 6

When the construction was expanded to include removing the tree, it was necessary to have the 580 Case in the stream and around the wet area below drains 7 and 8. At the conclusion of the project to repair drain 7, it was decided to remove the silt and organic debris from around the outlet of drain 7 and drain 8 and clean the area to make it easier to observe of seepage in this area. At the conclusion of the project the stream banks near the outlet of drain 7 and drain 8 and area near drain 6 was smoothed to a uniform grade, minus the cottonwood tree. A photograph of the final grade is shown in Figure 4 below.

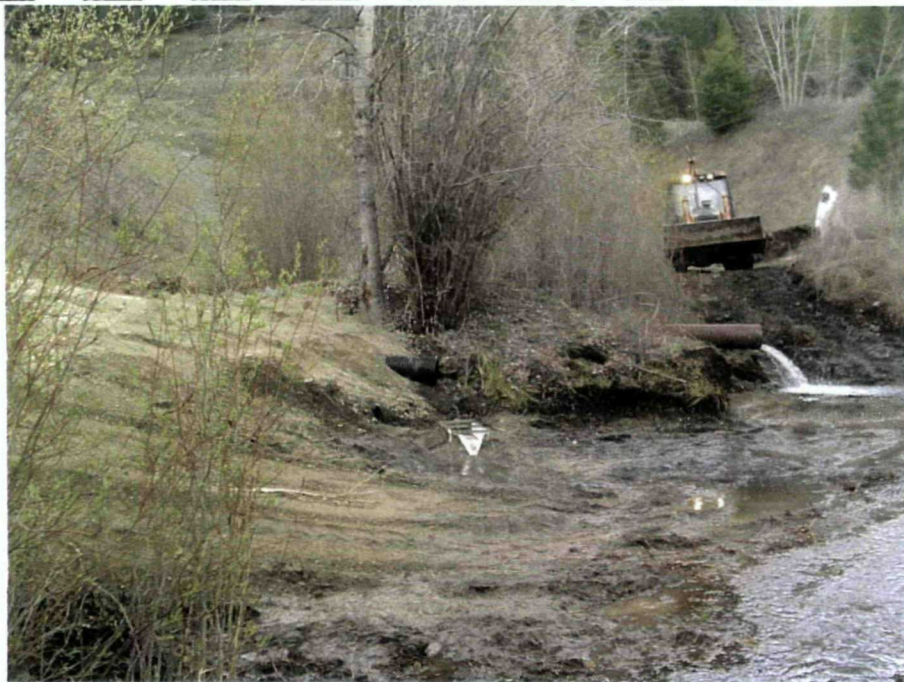
20. Across from drain 7

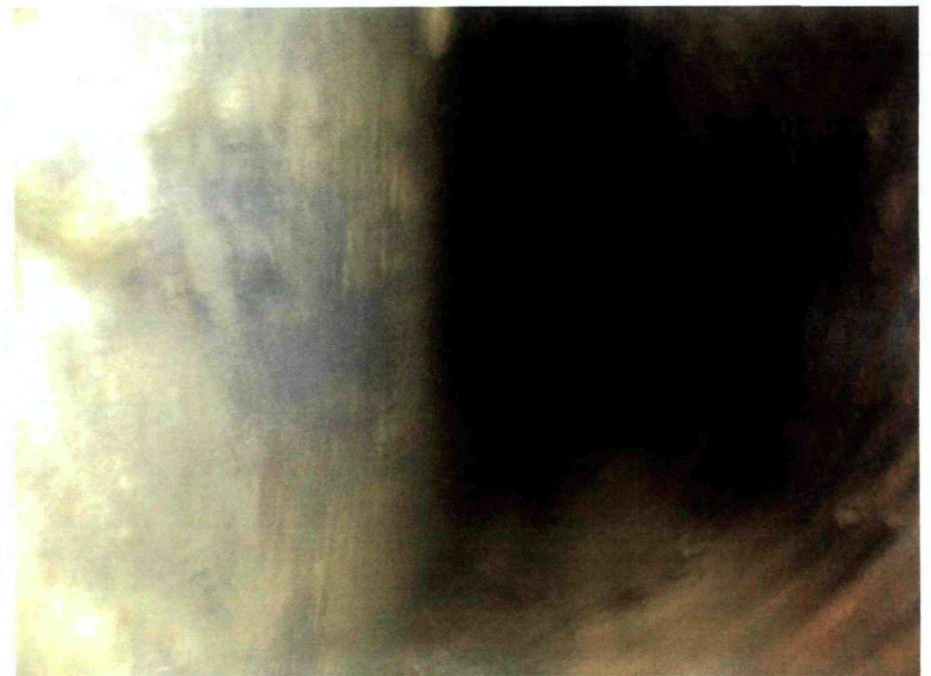
23. Material inside drain 2

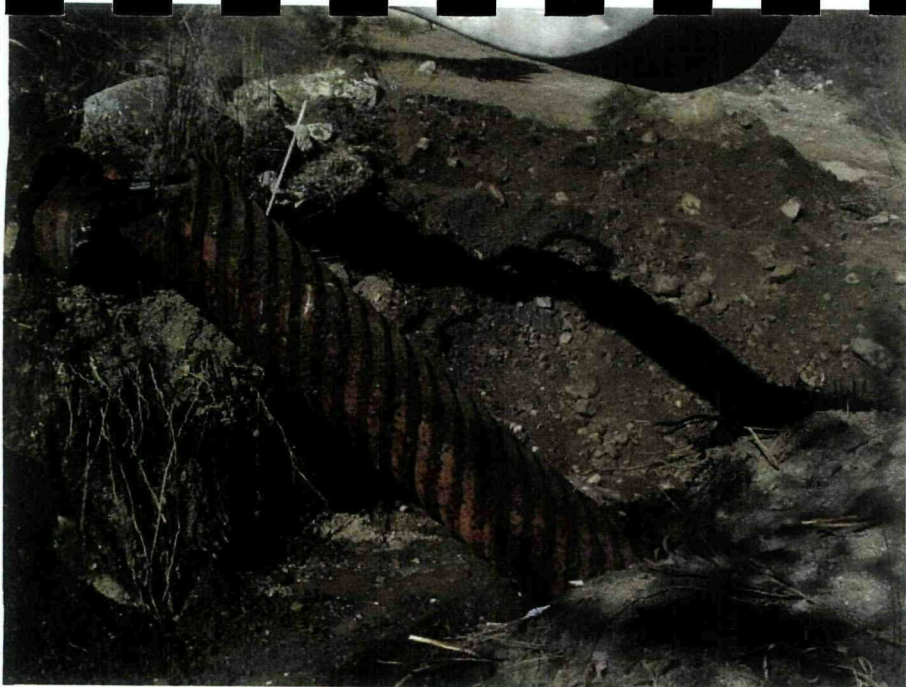
24. Inside drain 2

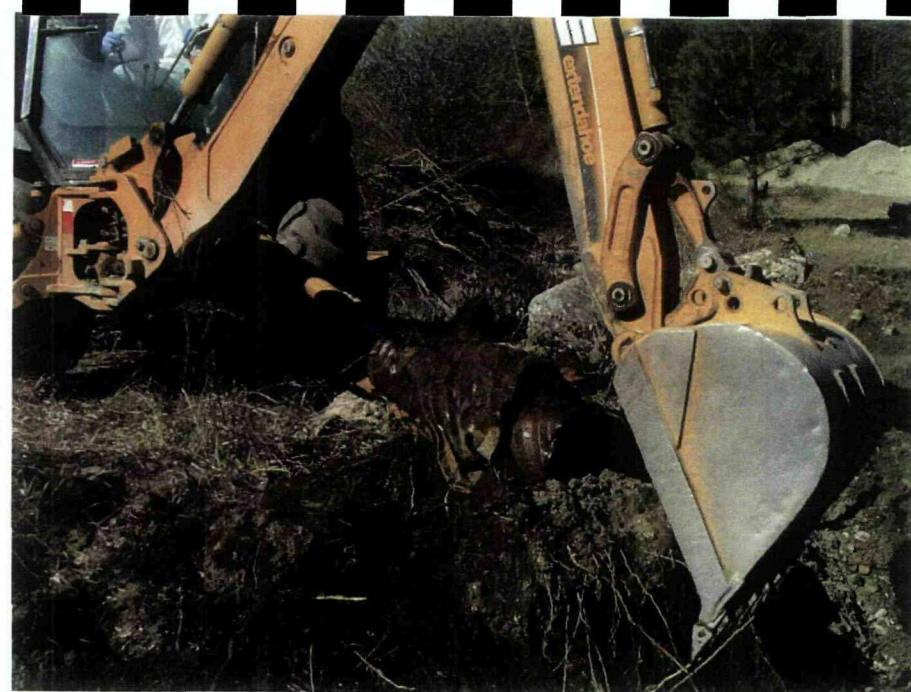
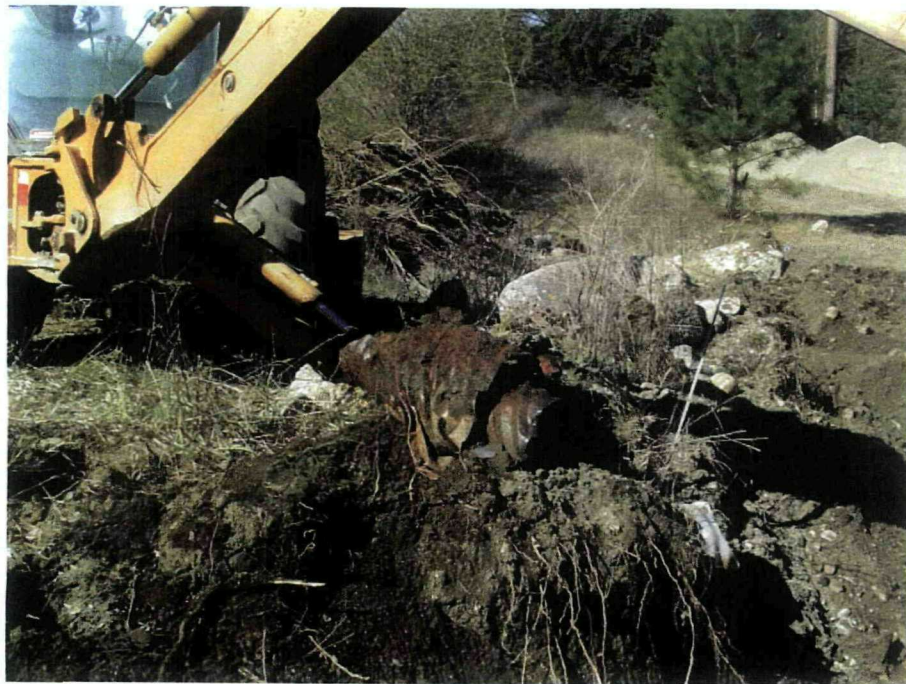
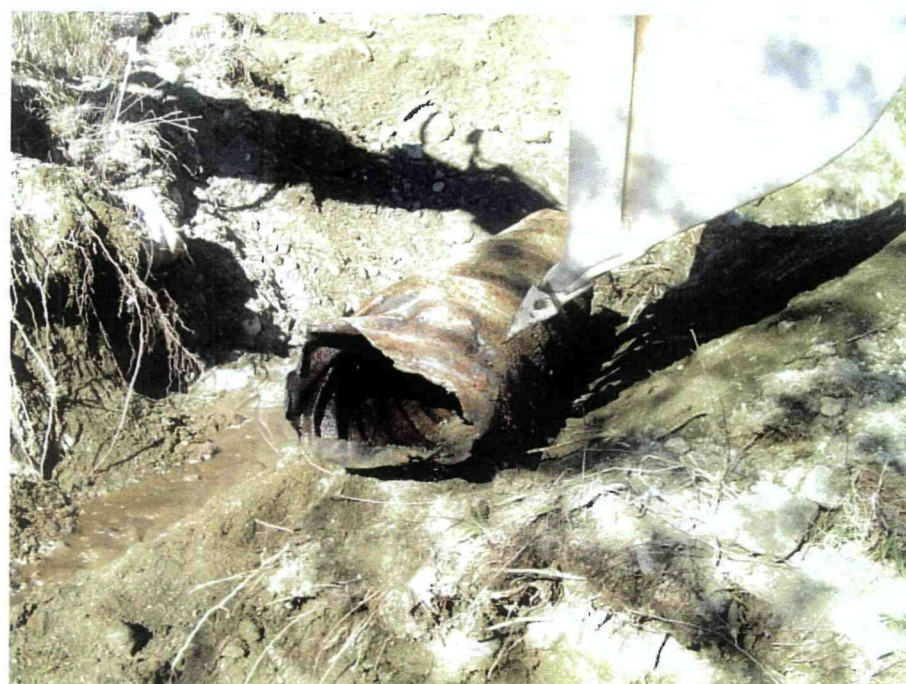
25. Outlet of drain 2, 12-inch culp

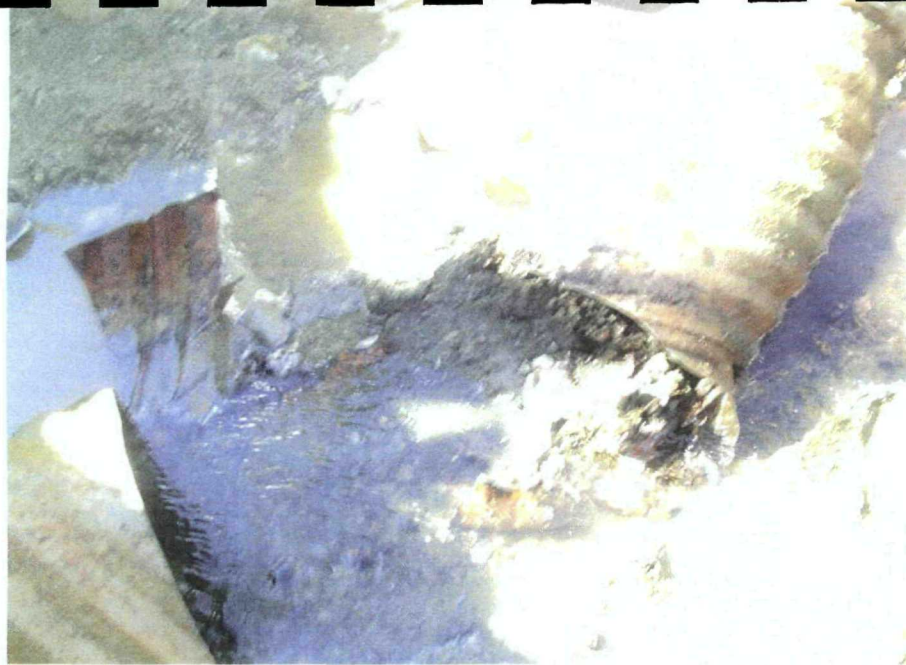
28. Drain 2 after cutting

1. The break in drain 2 needs to be repaired. As the break is near the surface and easy to access, the pipe can be excavated and a new segment added to the end of the drain.

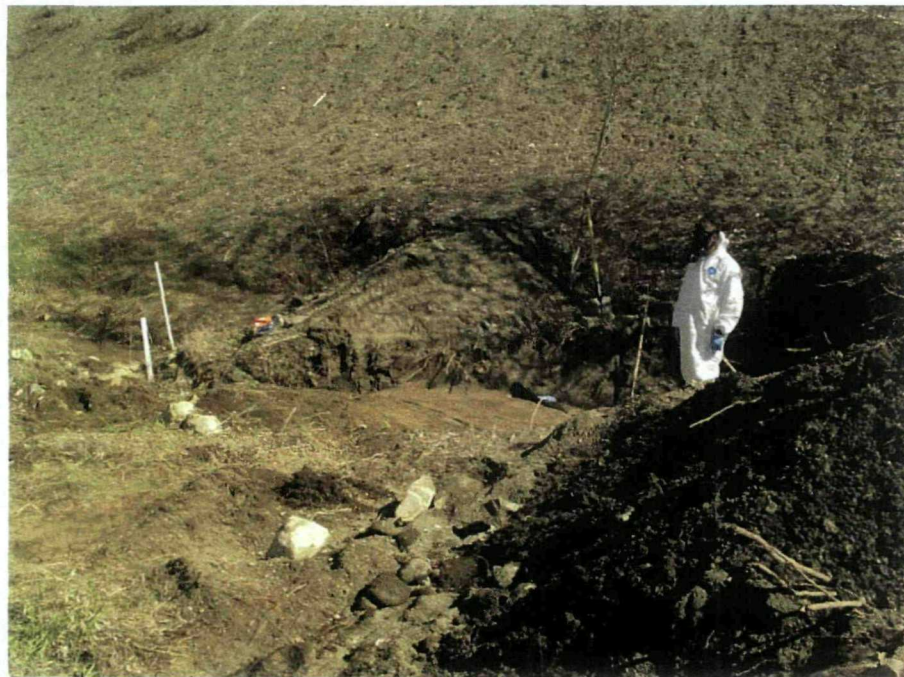
30. Inside drain 2

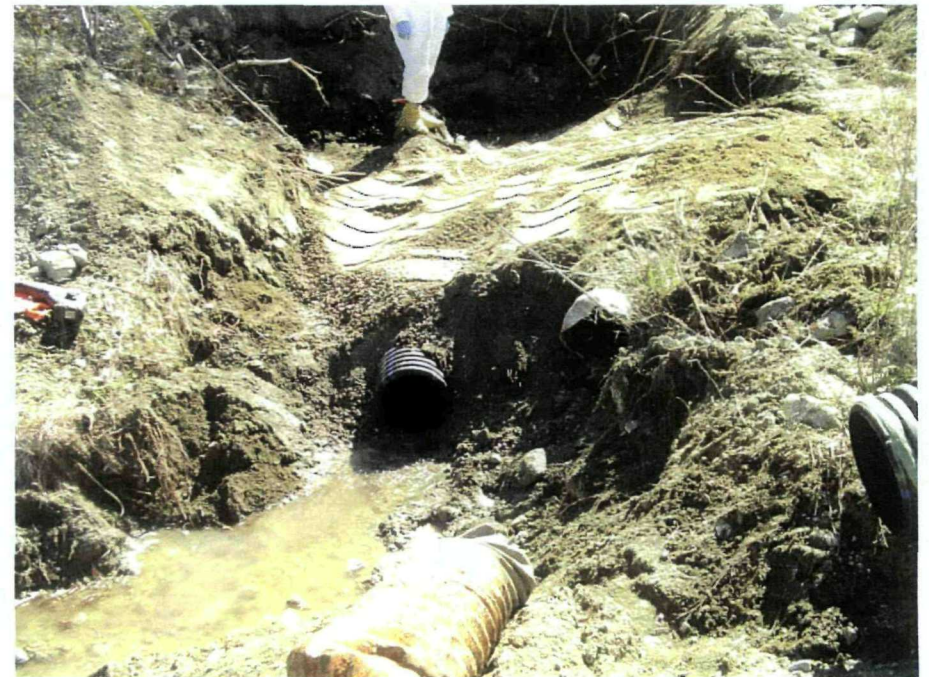
31. Backfilling drain 2

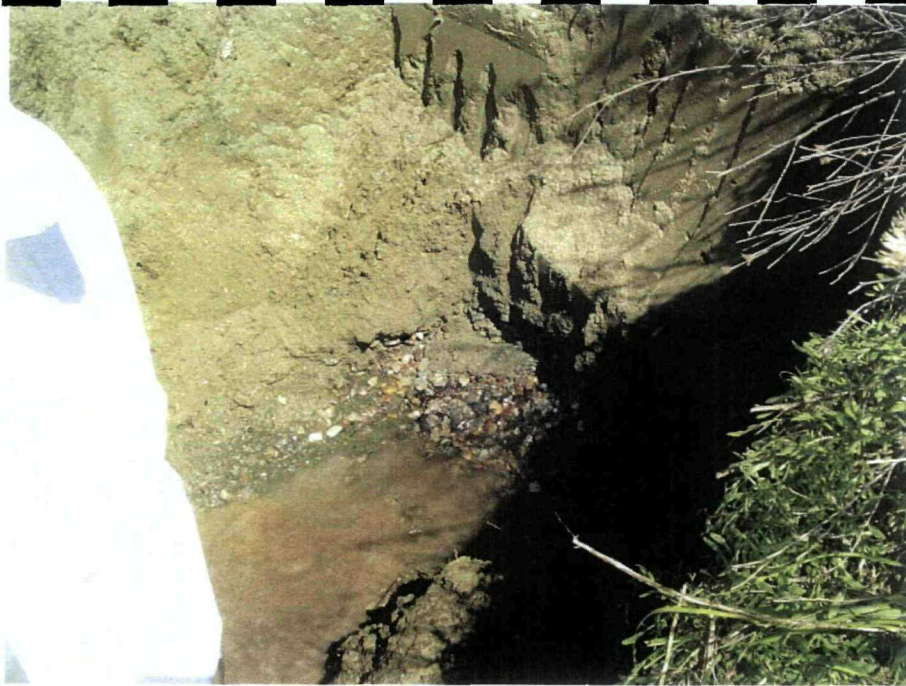
32. Outlet of drain 2 near drain 1

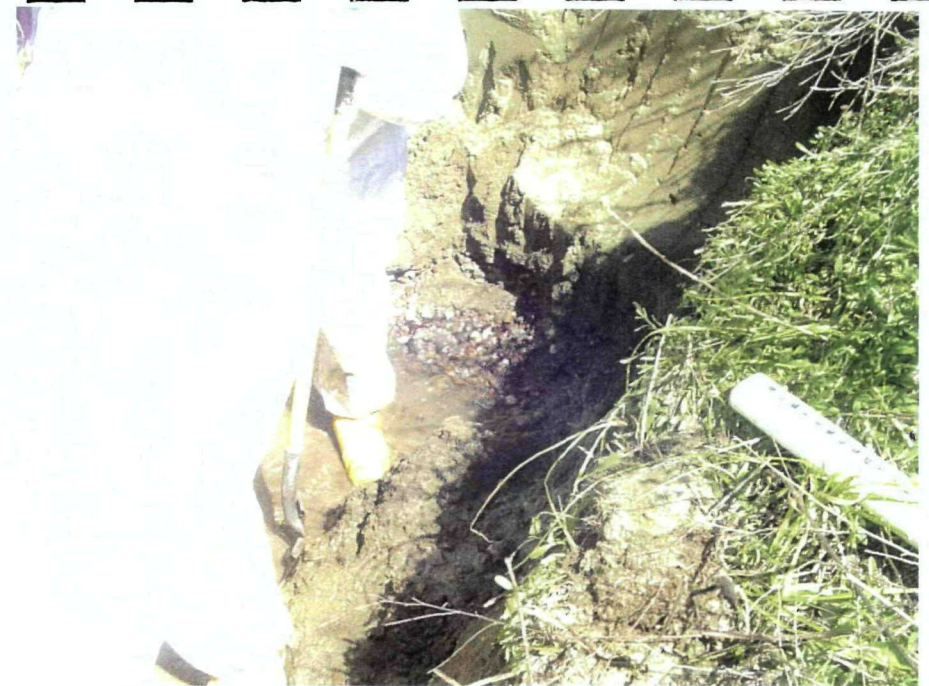
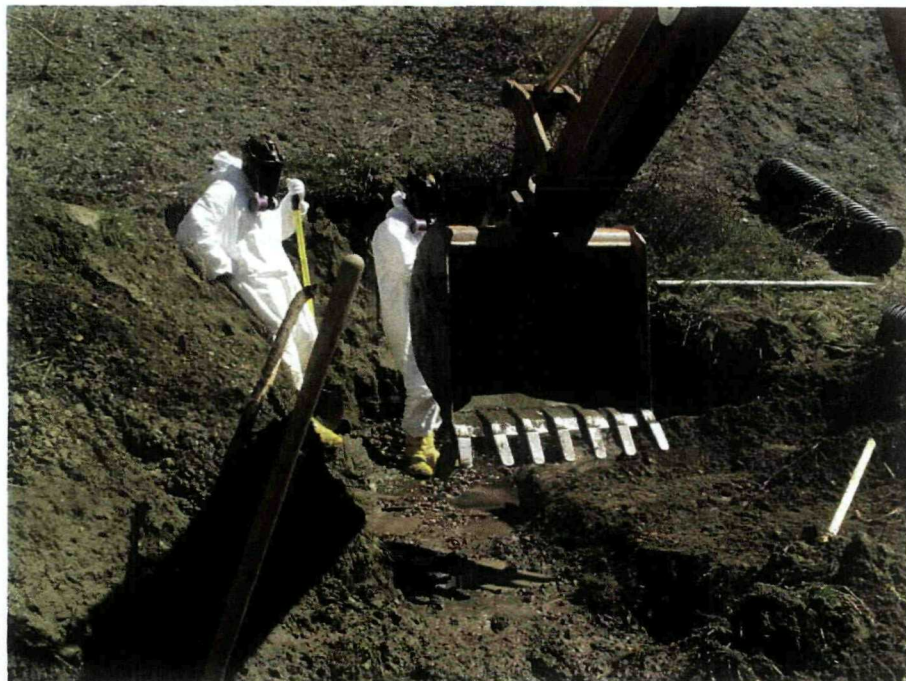
33. Terminal end of drain 11

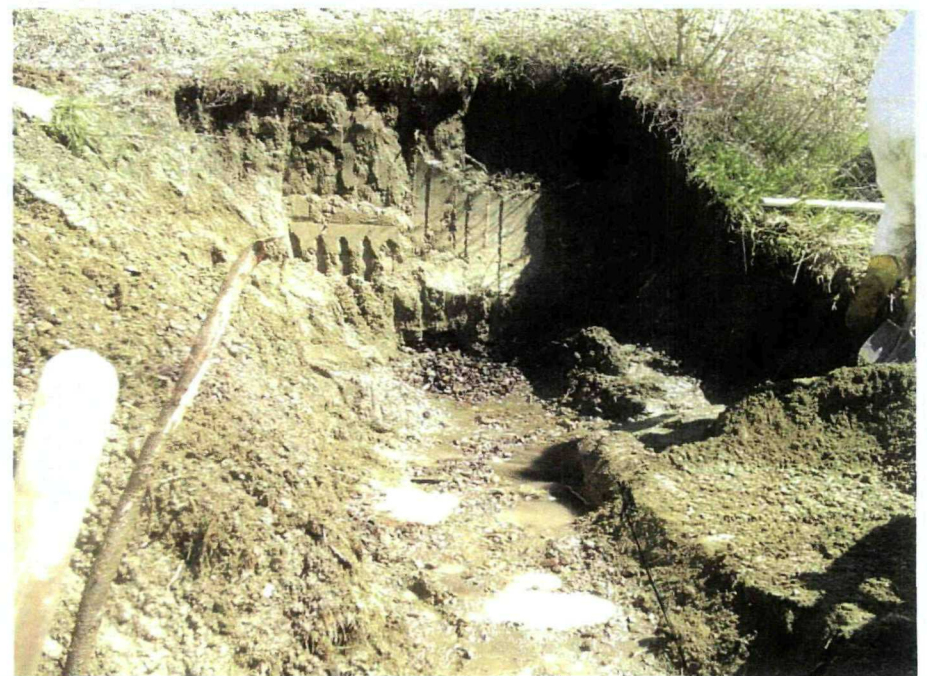
35. Excavating near drain 11

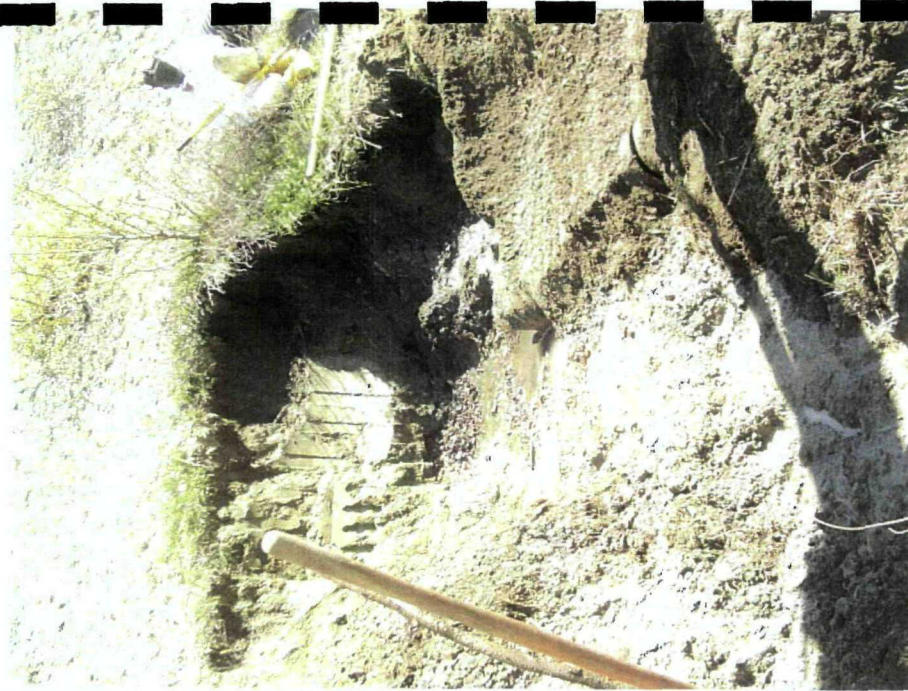
36. Same as #33, note end of drain 10

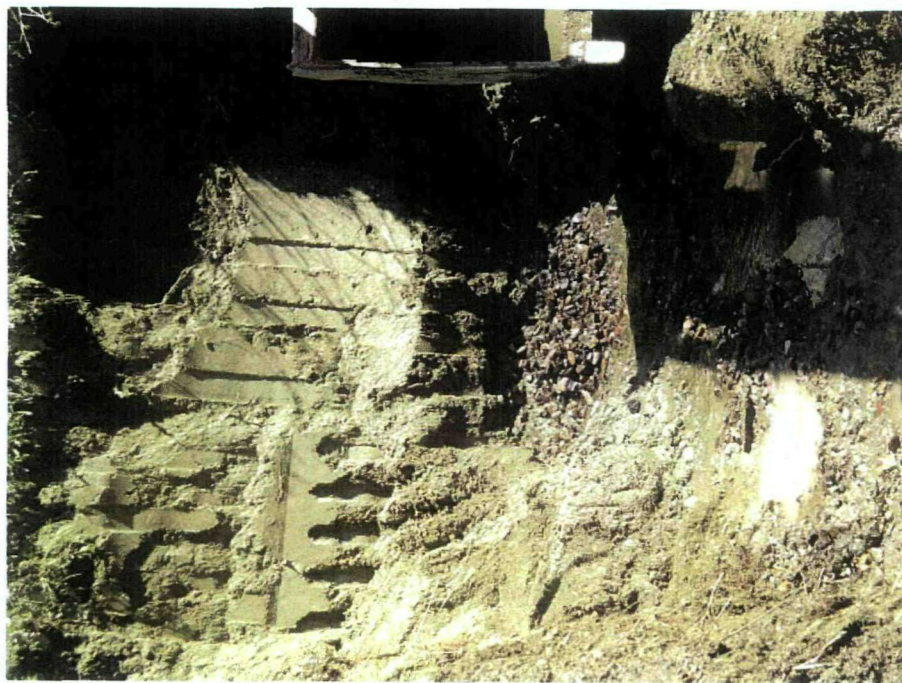
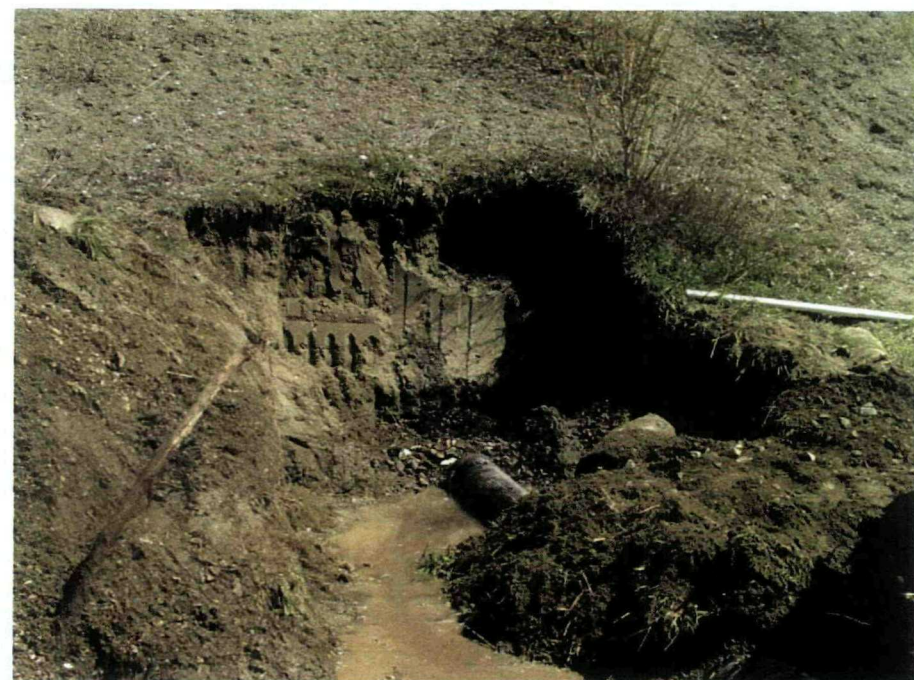
37. Terminal end, drain 14 and drain 10

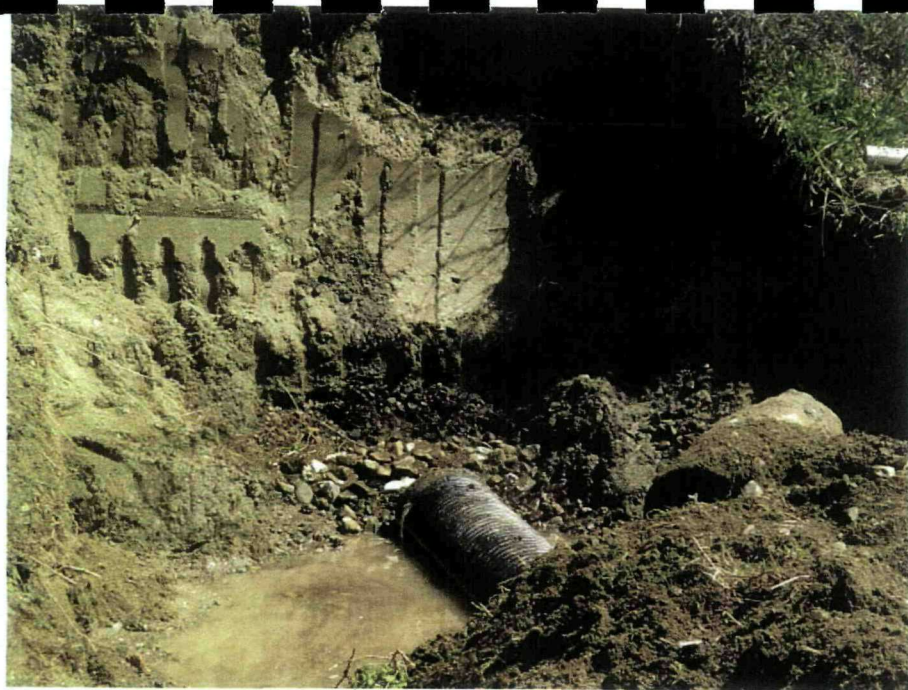
40. Placing round rock and new outlet drain 11

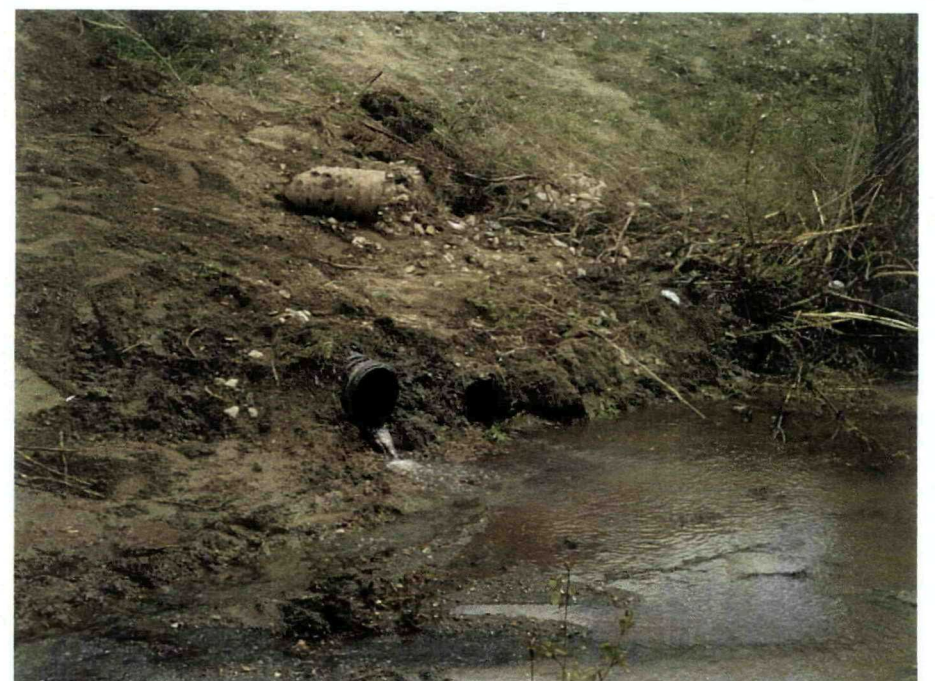
43. Final grade, drain 11 & drain 10

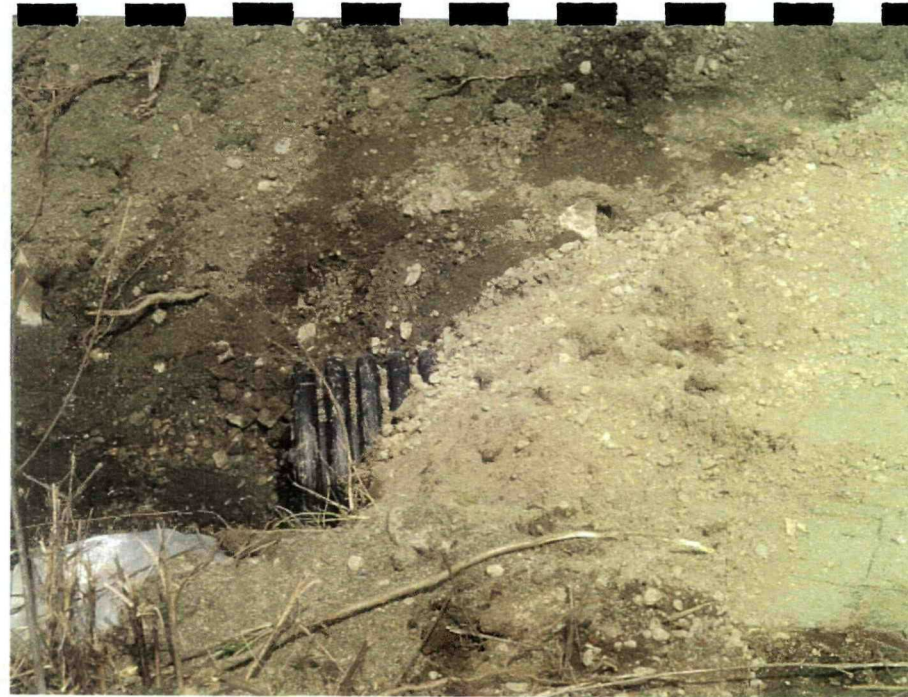
45. Final grade, drain 3
